*Beauty in architecture.
Tradition and contemporary trends*

PUBLISHING OFFICE PWSZ W NYSIE
NYSIA 2018

Beauty or truth – intervention dilemmas as exemplified by the conservation of wall paintings

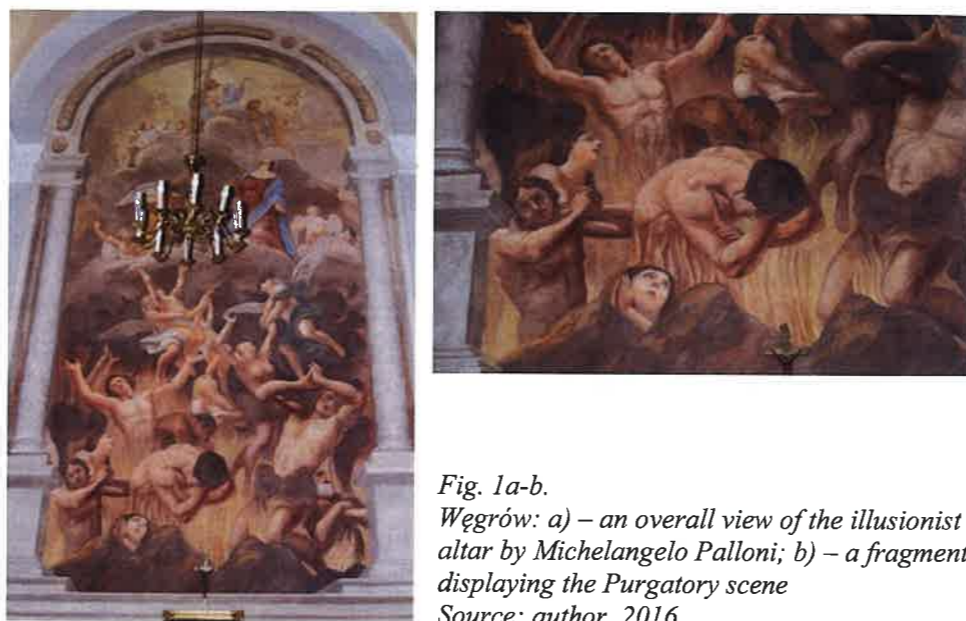
Fig. 1a-b.
Węgrów: a) – an overall view of the illusionist altar by Michelangelo Palloni; b) – a fragment displaying the Purgatory scene
Source: author, 2016

The frescoes to be found in the Węgrów Parish Church were created by M. A. Palloni between 1706 and 1707. They include nine illusionist altars situated in the presbytery (with the main altar dedicated to the Assumption of Mary), as well as eight side altars located in two chapels next to the presbytery, and in aisles. The conservation and restoration work on the church's wall paintings was conducted gradually, starting in the mid-1990s.⁴ The following restoration methods were employed: "the painting's colour reintegration by means of stipple dots, spots and lines" and "the reconstructed areas made with soft imitative spots matching the character of the original work"⁵. Unfortunately, instead of recreating the damaged fragments, the Węgrów paintings were over-painted and excessively stippled. In addition, the retouching work was conducted so clumsily that the Baroque wall paintings had irretrievably lost their illusionist character and lightness typical of the fresco-painting technique (Fig. 1a-b).

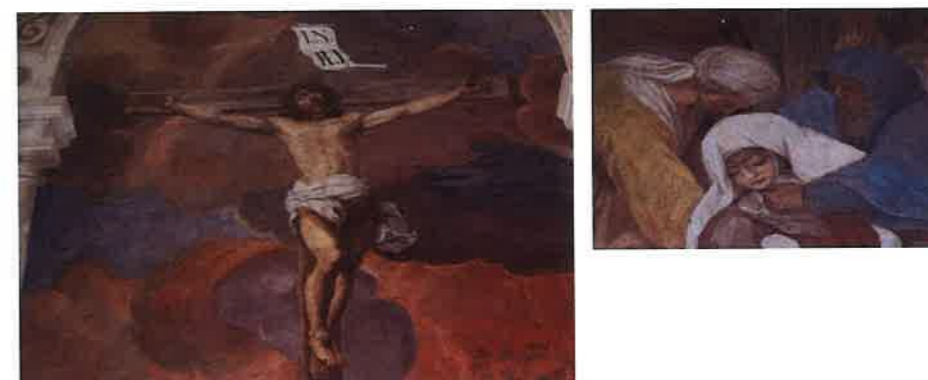
Fig. 2a-b. Węgrów, fragments of Michelangelo Palloni's wall paintings
Source: author, 2016

The space illusion effects and soft transitions of colours, jointly creating an impression of three-dimensional solids, were replaced by flat spots and vividly contrasted colours. In addition, due to strongly highlighted contours and light reflections, the painting forms reflected less and less of Palloni's unique style. The most serious objections concern the repainted Purgatory, Crucifixion and Baptism of Christ scenes (Fig. 2a). In the retouching process, the anatomies of many figures were deformed, which is best seen in the nudes (e.g. figures in the Purgatory scene, Saint Jerome and the Torturer) and faces (Mary and Mary Magdalene in the Crucifixion scene – Fig. 2b).

In the entire process, no thorough research into the condition of the original wall paintings was conducted, and expert supervision was not ensured. Efforts to restore the aesthetic quality of the church's decorations eventually led to destroying both the artistic and historical values of the original wall paintings. The conservation work, the principal objective of which should have been to preserve the monument, in fact resulted in what we may rightly call pastiche.

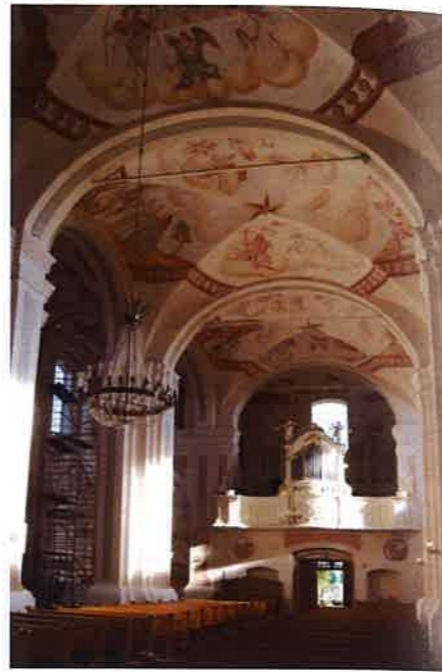
Fig. 3.
Strzegocin, wall paintings
by Wojciech Ślizawski – a view of the
nave towards the choir
Source: author, 2016

The initial conservation work was conducted between 1982 and 1990. Then, in 2016 and in the following years, various wall painting fragments on both aisle and nave bays were gradually being renovated (Fig. 3).

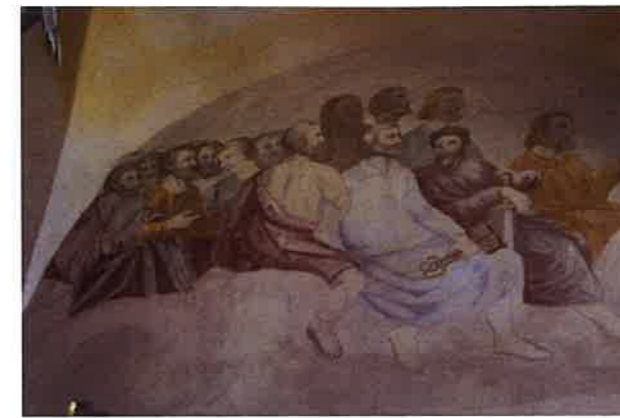
Fig. 4a-b.
Strzegocin, wall paintings
by Wojciech Ślizawski –
simplified, distorted figures
and ornaments
Source: author, 2016

The conservation work continued, and it was not until 2018 that the Conservation Commission became aware of the intensifying problems resulting from a poorly-formulated work plan. While the focus was on achieving the desirable aesthetic quality, the unresolved problems of the building-walls' moisture frustrated any painting restoration effects (those achieved both through previous and ongoing work) [12]. The second major drawback was the restoration method itself. Before the commencement of the most recent work, the Strzegocin paintings, whose predominant composition adhered to the Rococo style, had already been damaged and severely distorted due to previous restoration attempts. This was most likely the reason why the contractors found it so difficult to accurately reinterpret the painting and decoration's details. Unfortunately, their efforts have resulted in oversimplification and disfigurement, reflected in both the misidentified ornamental forms and the distorted anatomies of the represented figures (Fig. 4a-b). Additionally, the wall and ceiling backgrounds were painted in uniform colours. In consequence, the compositions and scenes now create an impression of having been cut out and randomly arranged over the surface. The illusionist, spatial, and delicately placed compositions became grotesquely flat and primitive, as if they had been painted by a contemporary amateur with little knowledge of basic painting techniques.

The Strzegocin church wall paintings, having been renovated, appear clean and bright. However, they have irretrievably lost their authenticity and beauty. Due to the low quality of the restoration methods, the current interior design is likely to invoke bewilderment rather than admiration.

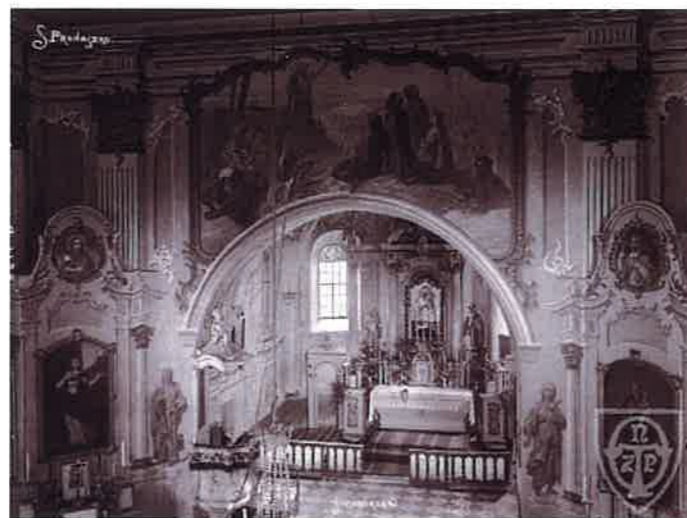
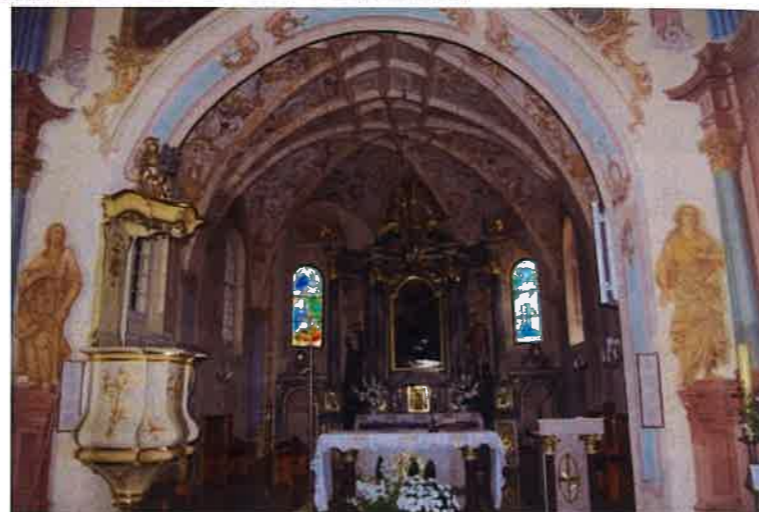
Fig. 5a-b. Smogorzów, a view of the chancel entrance and the presbytery:
a) – the 1909 look; b) – the 2016 look
Source: [17] and author, 2016

The current Church of the Visitation of the Virgin Mary in Smogorzów was erected in 1521, and the northern chapel dedicated to St. Anne was built in 1639. When the construction work (and interior decoration) had been completed, the church was consecrated in 1710. Modifications to the building were made around 1766, consisting of adding the south Holy Cross chapel. This was when the interior acquired a coherent rococo look. The wall paintings dating back to that time comprised a set of five illusionary altars (the main altar and four side altars under the chancel entrance and in both chapels). Until the mid-20th century, the Smogorzów church had been one of a few rococo sacral monuments in the northern Małopolska Region (Fig. 5a-b).

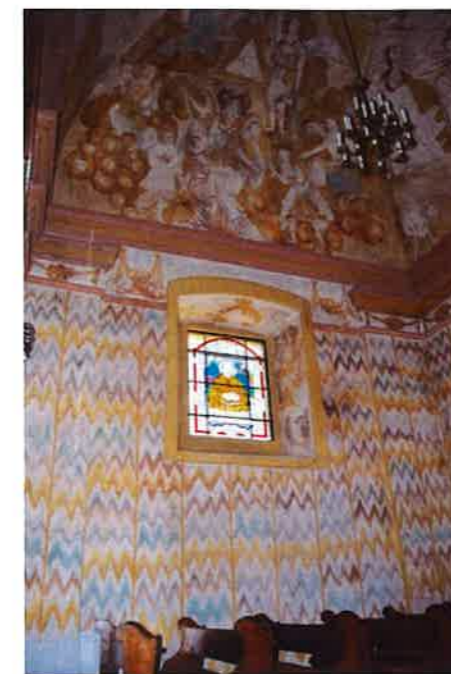
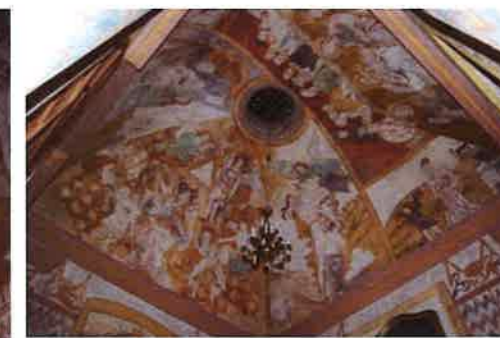
Fig. 6a-b.
Smogorzów, the look of St. Anne Chapel
after removing the rococo wall painting:
a) – a view of the wall and ceiling;
b) – a view of the ceiling
Source: author, 2016

We can hardly speak of any consistent approach to the implemented measures, as the subsequent restoration measures had different scopes. Between 1988 and 1990, the rococo wall paintings were removed from the St. Anne Chapel, and the 16th century paintings were exposed. However, once the wall and ceiling decorations were revealed, it turned out that, aesthetically speaking, they were rather primitive and parochial (Fig. 6a-b)⁷.

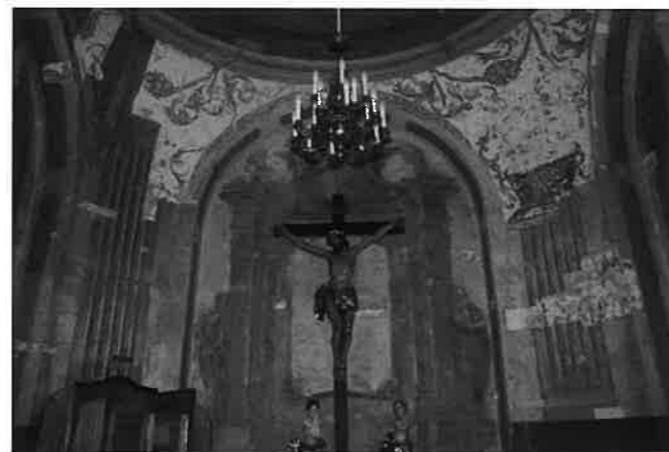
Fig. 7. Smogorzów, a fragment of the illusionist altar in the Holy Cross chapel with extensive exposures of the former decorative layer
Source: author, 2017

In recent years, in the Holy Cross Chapel other extensive uncoverings have been made, revealing the former decorative Baroque layer from before 1710 (Fig. 7). The artistic level of the uncovered wall painting fragments proved to be incomparably lower than that of the 18th-century layers. Nonetheless, the large exposed surfaces indicate that they were meant to prepare the walls for the subsequently-planned removal of the newer layer, as it was believed that the older decoration was more authentic, thus carrying more value. This can be understood as giving more priority to what was viewed as the truth of the monument over the beauty and artistry of the secondary layer, with the latter being treated as having little or no value. It was, therefore, expected that the coherent design, which had given the entire interior a specific aesthetic look, should yield to what was considered "truthful" merely because it was older.
